# Investigation of Damaged Old Buildings of Historic Town in Sichuan Earthquake

Zhaohua is one of historic towns of Sichuan province in China. On May 12<sup>th</sup> 2008, 232 historic buildings with through type timber frame were damaged in earthquake measuring 8 on Richter scale. The purpose of this report is to study the extent of damage to these historic buildings during the earthquake, and then attempt to find the weak points which these buildings displayed. In China, although a disaster prevention plan was in place for historic towns, mainly this plan focused on fire and did not include practical information on how to reinforce the historic buildings and what should be done during a disaster and post disaster.

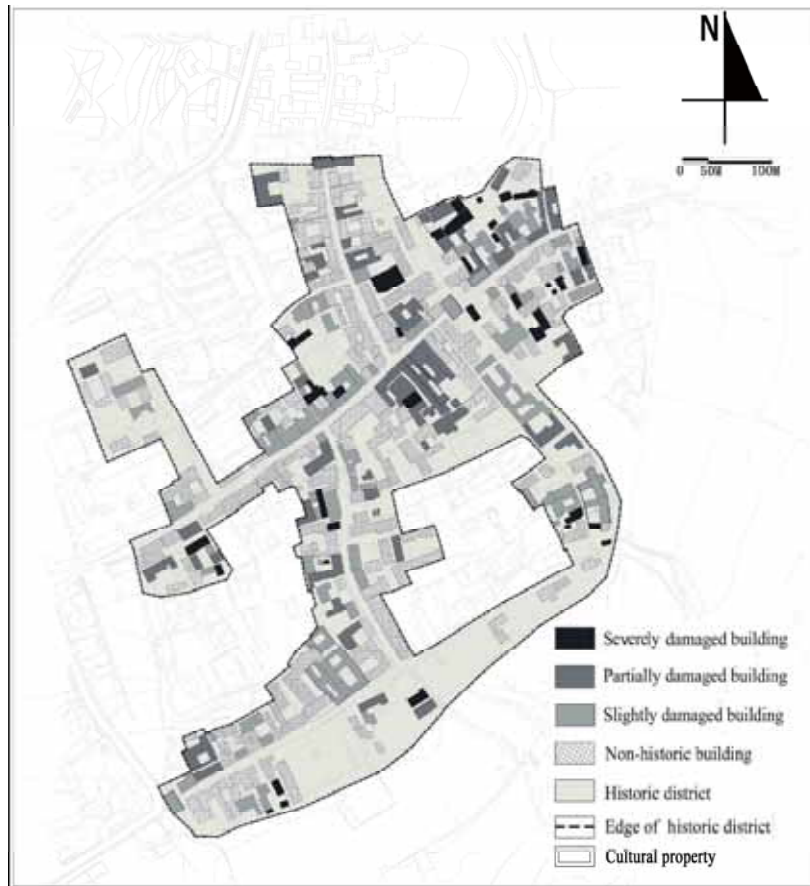
Fig.5 Damage Condition of Historic Buildings

Damage condition	Slightly damaged	Partially damaged	Totally damaged	Total
Numbers				
Damaged Numbers	112	74	46	232
Percentage	48.3%	31.9%	19.8%	100%

We found in our investigation: in 62 buildings with mud wall, the number of totally damaged buildings was 27 and accounts for 43.5%; in 162 buildings with brick wall, the number of totally damaged buildings was 18, accounting for 11.1%, the percentage of totally damaged buildings with mud wall is a significantly higher than damaged buildings with brick wall (Tab 2).

Type of historic building	Totally damaged		Partially damaged		Slightly damaged		Total	
	number	percentage	number	percentage	number	percentage	number	percentage
Mud building	27	43.5%	16	25.8%	19	30.7%	62	100%
Brick building	18	11.1%	67	41.4%	77	47.5%	162	100%
Wooden building	1	25.0%	1	25.0%	2	50.0%	4	100%
Total	46		84		98		228
