Revival from Earthquake Disaster and Asbestos Problems

ISHIHARA Kazuhiko^{*}

© The Policy Science Association of Ritsumeikan University:
Journal of Policy Science, 2012. ISSN 1881-6703. vol. 6., pp.113-119

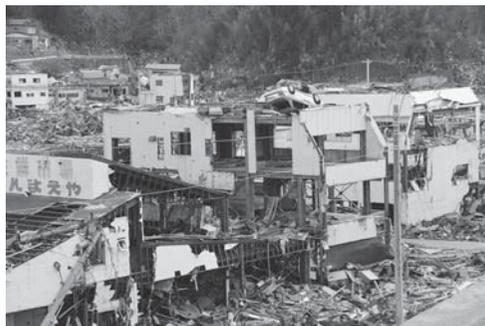
Figure 1. The building destroyed by Tsunami

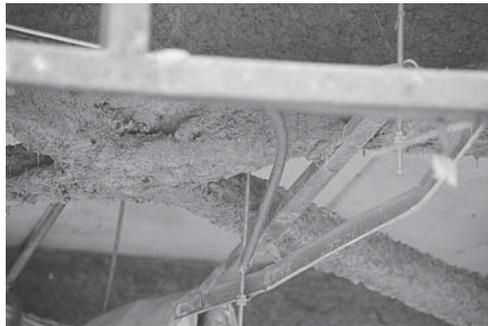
The Ritsumeikan Asbestos Research Project found two buildings which are used sprayed Asbestos, one was Crocidolite and another was Amosite. These buildings were not covered.

Figure 2. Crocidolite in the destroyed building

As for the Great East Japan Earthquake disaster, the risk of Asbestos disaster is lower than the Hanshin Awaji Earthquake. But there are two risks for fly Asbestos. One is the sprayed Asbestos in the buildings damaged by Tsunami, another is the boards including Asbestos. The sprayed Asbestos is open to the air in the buildings damaged by Tsunami and spread in the rubble. The boards including Asbestos are crushed and stocked in the stockyards of huge rubble.

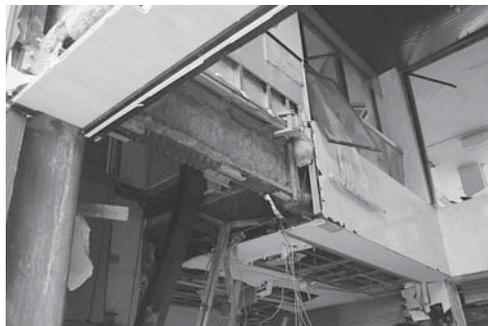
Figure 3. Amosite in the destroyed building

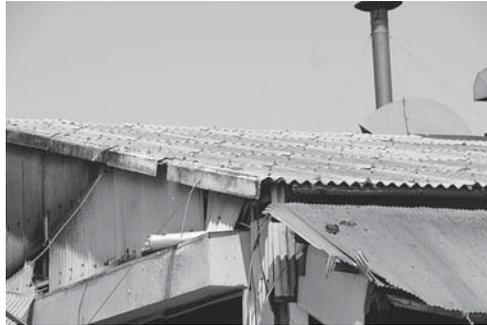
After the Tsunami, a lot of factories were destroyed. These factories used the boards including Asbestos. The rubble of the boards including Asbestos is stocked in the stockyards. In the stockyards, the rubble of the boards including Asbestos is crashed to small pieces. There is the risk of Asbestos fly.

Figure 4. Roof boards including Asbestos

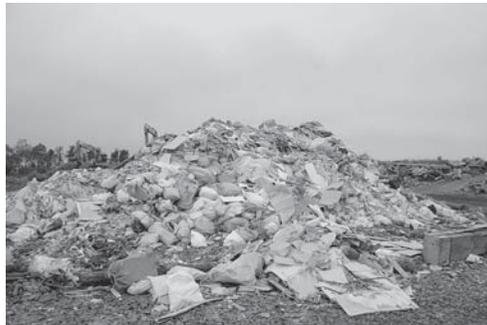
Figure 5. The boards including Asbestos in the stockyards of rubble
