Parametric Study and Dynamic Analysis of a Historical Masonry Building of Kathmandu

Key Words: brick masonry, finite element analysis, joint elements, Kathmandu

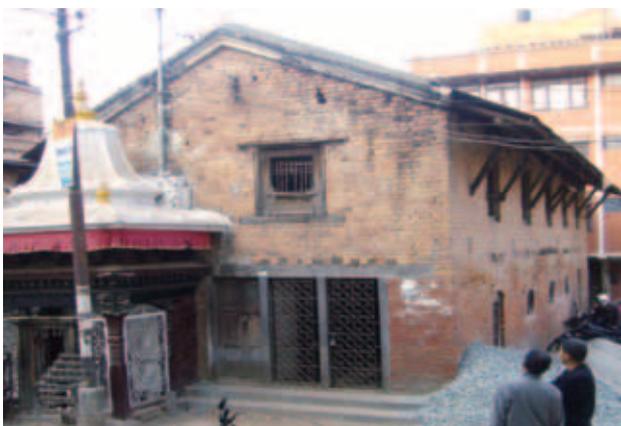
Fig. 1 Historical brick masonry house

The brick masonry building (Fig. 1) is located in Lalitpur Municipality of Kathmandu city. It has been divided into two rooms longitudinally (Figs. 6-7). It is a double storeyed building; 16.5 m long and 5.6 m wide. The wall is made of traditional brick and 60cm thick at the bottom and 50 cm at the top, a slight tapering from bottom to top. An average thickness 55cm is taken for an analysis. It was constructed three hundred years ago. It sustained damages in earthquakes and repaired many times. Recently, its original roof has been replaced by corrugated galvanized iron sheet which rests over wooden planks and battens and the interior wall has been plastered by cement sand mortar. The floor has been recently replaced by concrete which rests over wooden boards supported by planks and beams. Now, it is repaired hiding its original construction and has been using as public purpose. The building has very large opening in the front side. Wooden posts are supporting the wall of upper storey. In the upper storey, there is a big wooden window placed at mid span of the wall and is slightly projected to outside showing a nice aesthetic view.

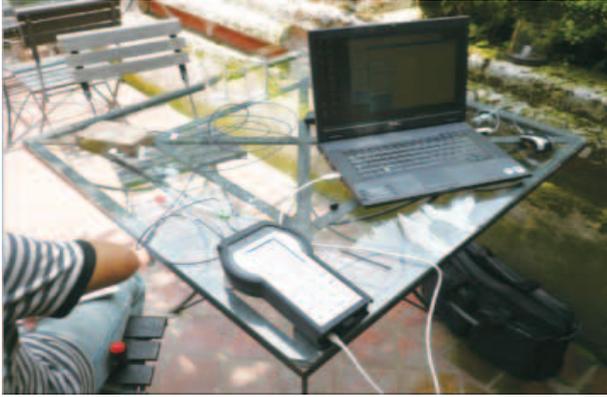
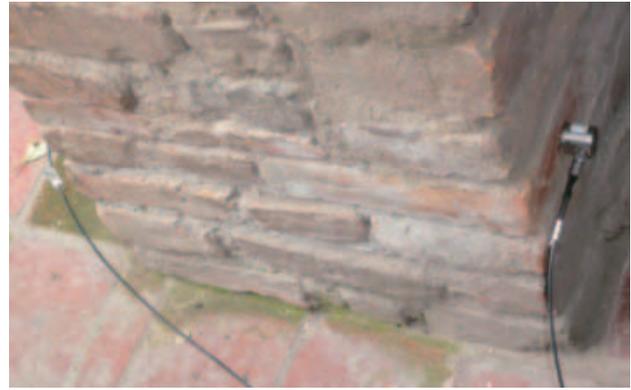
In Fig. 3, Pocket AE instrument (left) and sensor arrangement (right) are shown. At first, the wall was hit by a hammer near by the sensor location and the wave arrival times for both sensors were noted. Since, there are many joints in the wall, the arrival times were differed by the locations where the sensors had been put subsequently, calculated velocities also varied in wide ranges. Thus, series of measurements were taken at various locations in the same wall and in different walls with different thickness. P wave velocities are calculated from thickness divided by difference between arrival time of two sensors. From average value of primary wave velocity, unit weight (measured 19KN/m^3), and Poisson's ratio (assumed 0.2), modulus of elasticity (E) and shear (S) wave velocity (V_s) of the material are calculated, and shown in Table 1. Primary and shear wave velocities for three kinds of walls are shown in Table 1. Shear wave velocity for single brick wall (23cm long) is found 1531m/sec while the similar thickness wall which has one joint has shear wave velocity nearly half. 11cm wall has very close P wave velocity with single brick because it does not have joints through cross section. As the wall thickness increases, number of joints in the wall increases and primary and shear wave decreases (Fig. 4).

Fig. 3 Instrumentation of two channel Pocket AE
