# Study on the Damage of Residential Buildings of Jiuzhaigou Tibetan Villages in World Heritage Sites

Jiuzhaigou, one of the world natural heritage sites in China, was severely damaged by the earthquake in August 2017, and many traditional Tibetan residential buildings in its villages were seriously damaged. This paper takes the damaged Tibetan style residential buildings in Jiuzhaigou villages as research subject. The research methodologies of this paper include 1. the field investigation; 2. analyze the earthquake damage and post-earthquake restoration of the residential buildings; 3. Explore the correlation between local Tibetan traditional building structure, construction characteristics and earthquake damage. Finally, it is expected that the results of this study could be a valuable reference to the conservation and restoration of those vernacular residential buildings with local regional characteristics after earthquakes.

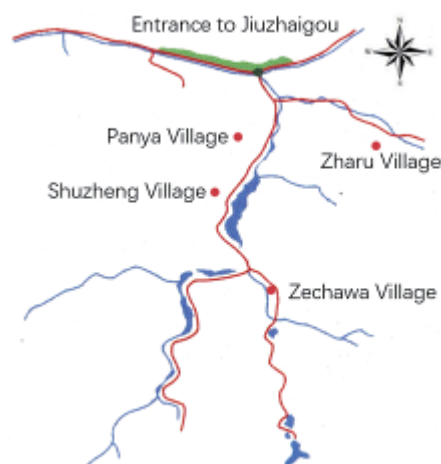
Fig. 2 Village Distribution

Along the river, nine Tibetan villages are distributed in the valley (Fig.2). Since it is located in the border area of Sichuan Basin and Qinghai-Tibet Plateau, Jiuzhaigou village region is the Multi-ethnic mixed

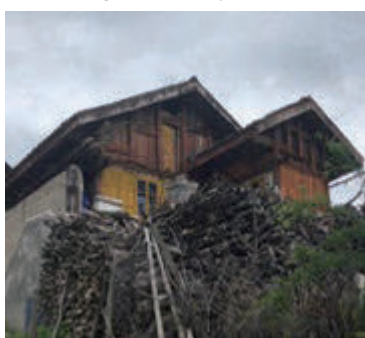
Fig. 4 General Style

The buildings in this style category were mainly built in the late 1990s to the early 20th century, and most of them are 2-4 stories. The buildings are mainly brick structure or framework dwellings. The roofs were covered with small green tiles, color steel plate slope roof, the facade is mostly red paint-based sand wall surface, no painting, the overall style is simple, doors and windows were nearly modern transformed (Fig.4)

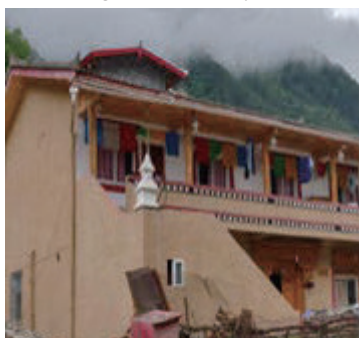
Fig. 5 Poor Style

The buildings in this style category were mainly built around 2010, most of them were 1-4 stories, made of brick structure or framework structure. The roofs were slope roof or flat roof covered by cement or color steel. Facades were nearly made of modern style doors and windows, and a few decorative abstract Tibetan patterns. The building materials of this style were mainly various types of tile veneers, and a small part of them use the fair-faced concrete (Fig.5). Based on field surveys, the overall current situation of the 4 villages' building styles is shown in Table 1 and Table 2:

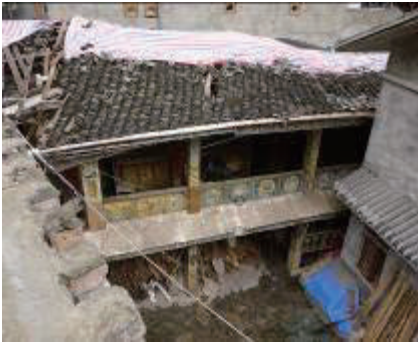
Fig. 6 Tile Falls

In the survey of four villages, the damaged parts of the buildings were similar in all of the three damage levels. The slightly damaged buildings were mostly roof tiles falling, external wall or soil wall cracking, veneer peeling, fence damage, etc.

For slightly damaged buildings, the roofs were repaired with new materials like tiles or colored steel plate, and the cracks in the walls are filled with cement mortar and face brick.

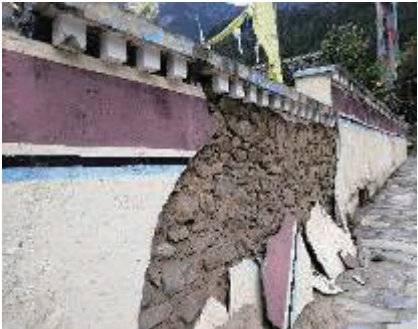
Fig. 9 The Wall Materials Fell

In partially damaged buildings, most of them were roof tiles fall inclined structures, collapsed external walls or multiple cracks etc. While in the fully damaged buildings, the external walls of buildings in the four villages are partially or completely collapsed. The details of damaged parts of the buildings under investigation could be found in Table 6.

For partially damaged buildings, the roofs were re-shingled, but the gable, external wall and structural tilt have not yet been dealt with. For fully damaged buildings, such as partial or complete collapse of external walls, people chose to rebuild brick walls, wooden supports, wooden external walls and some have not yet been repaired (Figure 15). Among the surveyed villages, still some differences exist in the repairing of damaged buildings (Table 7):

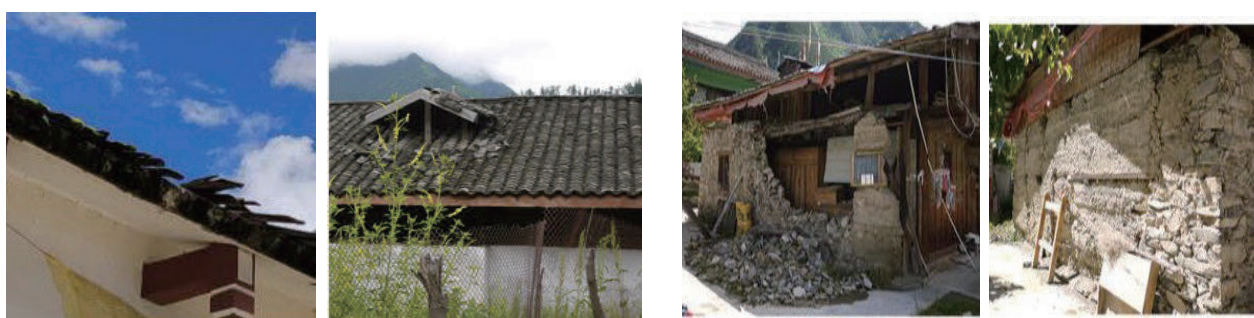
Fig. 15 Comparison of Roof Damage Repair
