# Research on Disaster Damage of Immovable Cultural Relics in China in Flood Season of 2020

2020 China floods were the worst in more than two decades, causing severe damage to immovable cultural relics. Through a large number of literature collection, the damage relics affected by floods in China in 2020 was summarized and sorted. The damaged immovable cultural relics are summarized into three types: ancient bridge, ancient architecture and ancient site. The typical damaged cultural relics, such as Zhenhai Bridge, Rainbow Bridge, Wind-rain Bridge, Guanyin Pavilion and Xiangyang City Wall, are listed in the form of pictures and texts. Finally, the problems existing in the protection of immovable cultural relics are summarized, and three conservation suggestions are put forward.

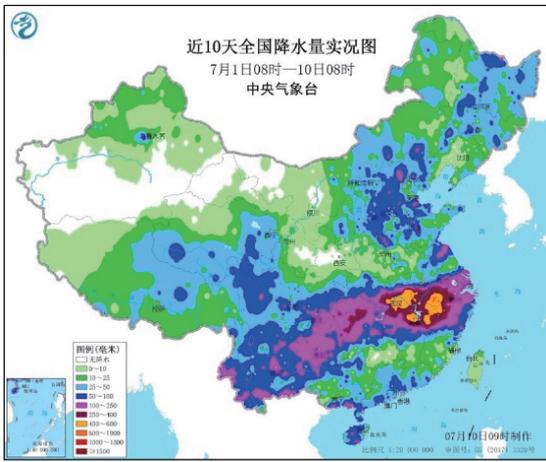
Fig. 1 The actual rainfall in the main flood season<sup>6)</sup>

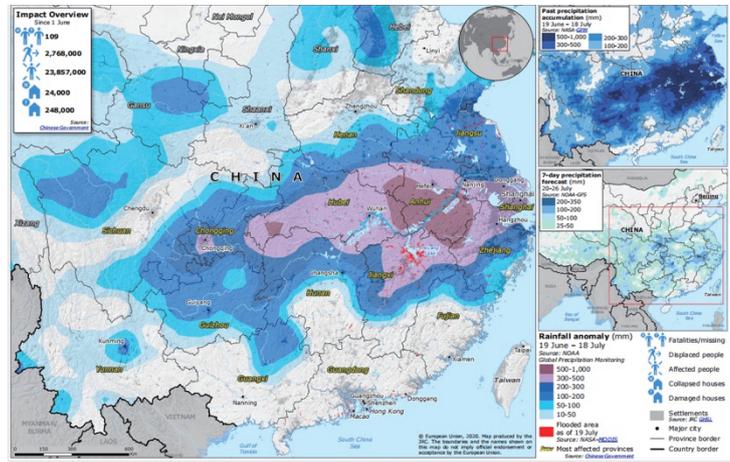
Fig. 2 Rainfall analysis chart of the Yangtze River Basin<sup>7)</sup>

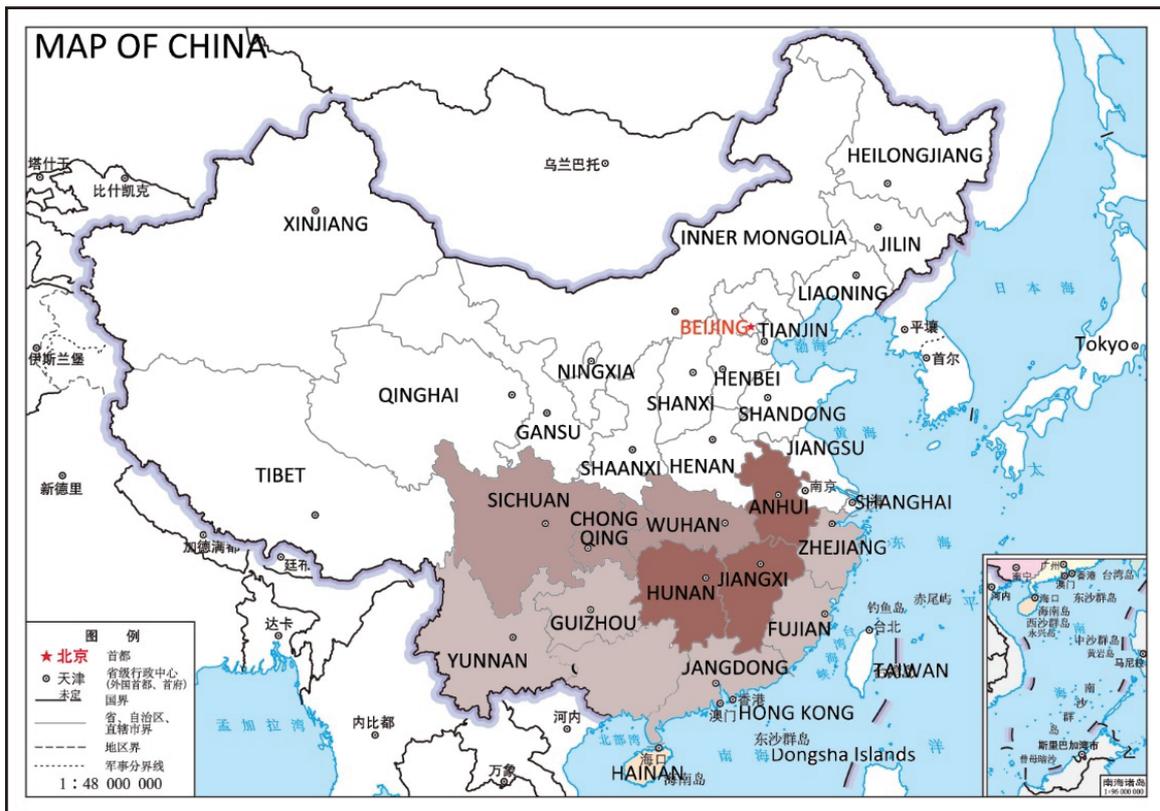
Fig. 3 Distribution map of immovable cultural relics damaged by flood in each province (drawn by the author)

Influenced by heavy rainfall in the flood season of 2020, severe floods, landslides, mudslides and other geological disasters occurred in many places, and some cultural relics were seriously damaged. According to statistics from the National Cultural Heritage Administration (NCHA), as of July 16, more than 500 immovable cultural relics in 11 provinces have been damaged by floods to varying degrees, including 160 in Jiangxi, 144 in Anhui, 62 in Hunan, 41 in Sichuan, 35 in Guangxi and 31 in Hubei., 76 key national cultural relics and 187 provincial cultural heritage sites have suffered damage of varying degree<sup>8)</sup>.

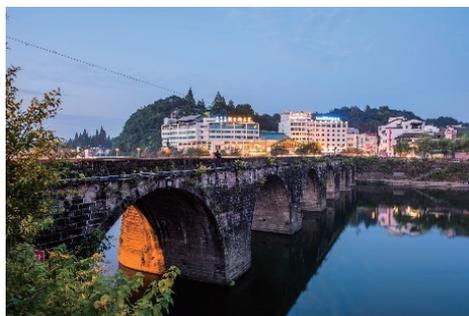
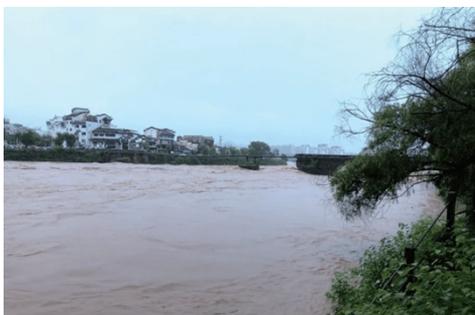
Zhenhai Bridge was built in 1536, the 15th year of the reign of Emperor Jiajing of the Ming Dynasty. The bridge went across the Heng River, and had a total history of more than 400 years. The bridge was 133 m (436 ft) long and had 15 m (49 ft) wide. It is a stone arch bridge with six-pier and seven-holes<sup>9)</sup>. Zhenhai Bridge is one of the rare large stone arch Bridges of Ming Dynasty in Anhui Province, which is of high historical, cultural and scientific value. Due to continuous heavy rainfall, especially the flood caused by continuous rainstorm from the evening of July 6 to the morning of July 7, 2020, due to continuous scouring and long-term high water level soaking, Zhenhai Bridge, one national-level cultural relics preservation unit, was washed away by the flood at about 9:50 a.m. on July 7, 2020, and the bridge components and stones were scattered in the water<sup>10)</sup>.

Fig. 4 before the damage

Fig. 6 before the damage<sup>11)</sup>

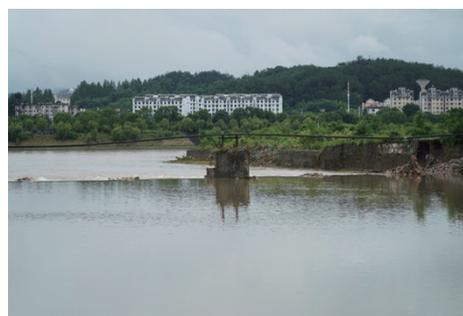
Fig. 5 in the renovation<sup>11)</sup>

The main purpose of this restoration is to continue the memory of history and culture and the inheritance of traditional skills. In order to maximize the original appearance of Zhenhai Bridge after maintenance, as well as the stability and durability of the bridge structure, modern technology has been used to optimize the maintenance of the foundation, and bored piles and concrete bearings were used in the restoration project, according to the report. The pier and the bridge deck still use the original masonry structure. How to combine traditional technology with modern technology has become the main problem that the expert group needs to solve.

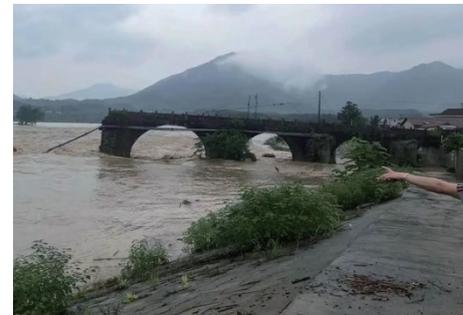
Fig. 7 after the damage<sup>11)</sup>

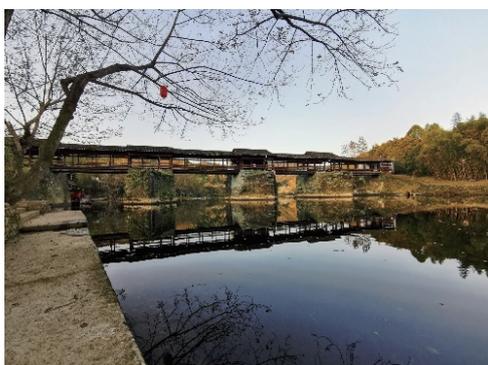
Rainbow Bridge, an 800-year-old covered bridge in Qinghua Town, was submerged by more than one meter. Rainbow Bridge adopts the structure of four piers, five holes, five pavilions and six corridors. Among the stone piers, the sharp part, commonly known as the "swallow mouth", can reduce the impact of floods on the piers<sup>11)</sup>. Due to the huge impact of the flood, the deck (two corridors and one pavilion) between the east approach bridge and the No.2 pier of the rainbow bridge was washed away, while the rest of the bridge body was basically intact, and the submerged "swallow mouth" pier was still intact. At present, the main structure of the ancient bridge piers is basically well preserved, with only some wooden buildings and the surface layer of the bridge deck damaged, which is not difficult to repair in the later stage<sup>12)</sup>.

Fig. 8 before the damage

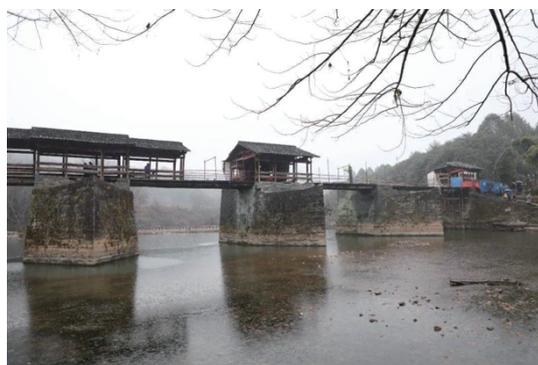
Fig. 9 in the renovation<sup>13)</sup>

After the disaster, Wuyuan in Jiangxi Province issued a "Rainbow Order" to search online for logs washed away by floods. So far, more than 70 lost wooden components have been recovered. Focusing on the repair policy of "Conservation First, Rescue First, Rational utilization, and Strengthened management", traditional techniques will be adopted to ensure the integrity and authenticity of the ontological structural system of the Rainbow Bridge to the greatest extent, so as to truly "Repair the old as the old". This repair will carry on the comprehensive repair to the bridge deck brick wood structure, the partial restoration, the bridge pier and so on carries on the reinforcement.

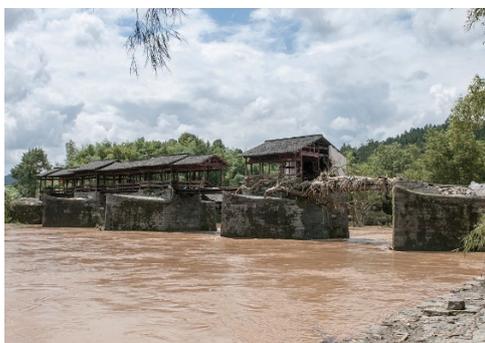
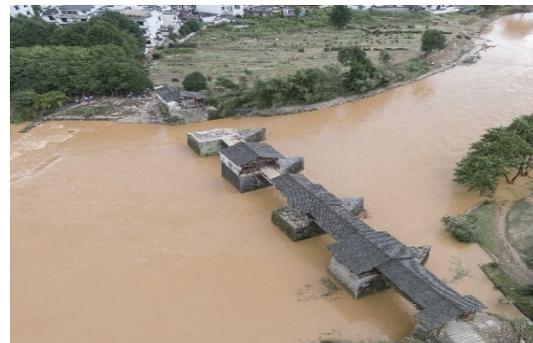
Fig. 10 after the damage<sup>13)</sup>

Fig. 11 after the damage<sup>13)</sup>

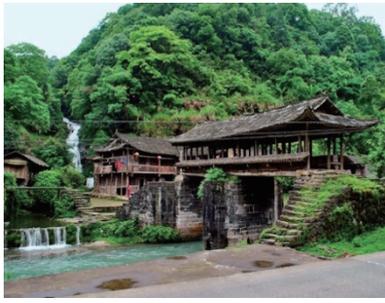
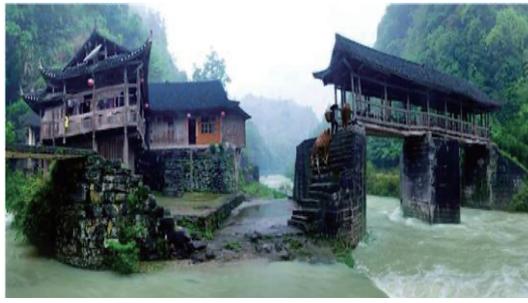
Matouxi Wind-Rain Bridge is located in Wangjiaping Town, Zhangjiajie City. It was built in the late Ming and early Qing dynasties and has a history of more than 300 years. Matouxi Wind-Rain Bridge is a typical Tujia folk architecture with two holes and three piers shingle structure<sup>14)</sup>. In the early morning of June 13, torrential rain and mountain torrents surged. Near 10 a.m., the 300-year-old bridge collapsed and was engulfed in the flood, leaving its lone piers<sup>15)</sup>. After the disaster, the villagers spontaneously salvage, and the original components such as keel and pier stone will be used for future restoration.

Fig. 12 before the damage

Fig. 13 before the damage<sup>16)</sup>

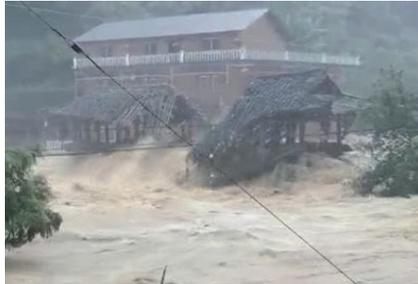
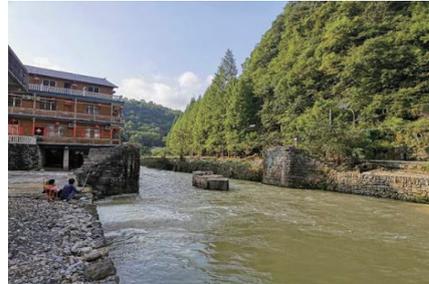
Fig. 14 after the damage<sup>14)</sup>

Fig. 15 after the damage<sup>14)</sup>

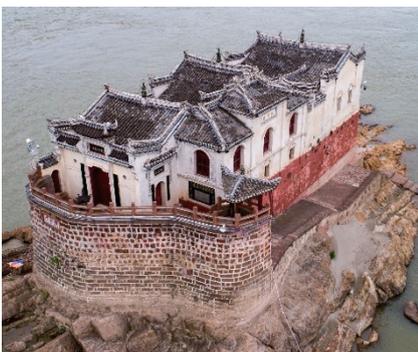
It is known as the "first pavilion of the Yangtze River" in Hubei Ezhou Guanyin Pavilion, is the only temple on the Yangtze River. Ezhou guanyin pavilion sits east to west, standing against the water, stone, brick, wooden frame structure pavilion type building, the pavilion is 24 meters long, 10 meters wide, 14 meters high. The Pavilion has one pavilion, two halls and two floors, a total area of more than 300 square meters<sup>17)</sup>. The damaged parts of Guanyin Pavilion mainly include the wooden columns inside the pavilion, the white grey stone walls and the red roof beams inside the temple. Among them, some degree of corrosion appeared after the wood column was soaked by river water, and some of the coating on the wood column peeled off. White grey stone wall inside the temple also suffered river water corrosion, stone wall outside the surface of the protective layer was destroyed. The tie brushed in red pain also have been came off.

Fig. 16 before the damage

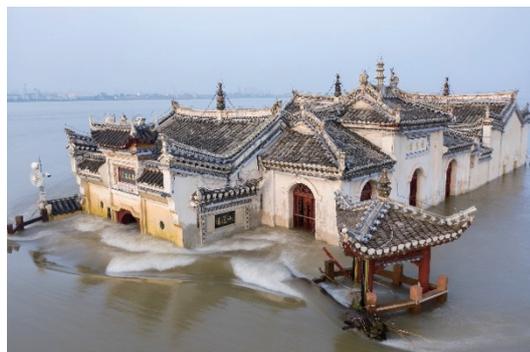
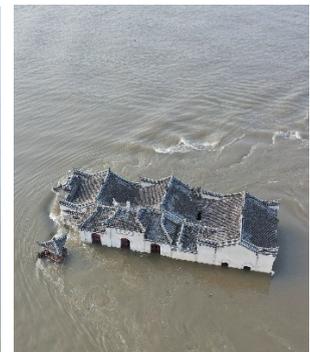
Fig. 17 after the damage<sup>18)</sup>

Fig. 18 after the damage

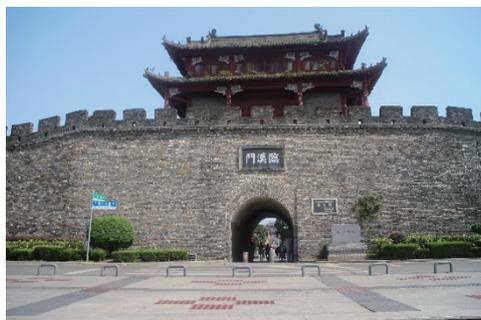
Xiangyang ancient city wall, with a total length of 7.33 kilometers, was announced as a national key cultural relics protection unit in 2001<sup>19)</sup>. The existing city wall was basically built in the Ming Dynasty, with bricks outside and rammed earth inside. Due to long-term rain erosion and penetration, on 20 June 2020, the central wall of the eastern section of Xiangyang City Wall (about 150 meters to the south of the east gate) partially collapsed, with a length of about 10 meters. After the disaster, the restoration began with the removal of collapsed bricks and rammed earth. Then began to repair and reinforce the damaged parts of the ancient city wall, additional reinforcement measures were added to the foundation of the collapsed section of the city wall<sup>20)</sup>.

Fig. 19 before the damage

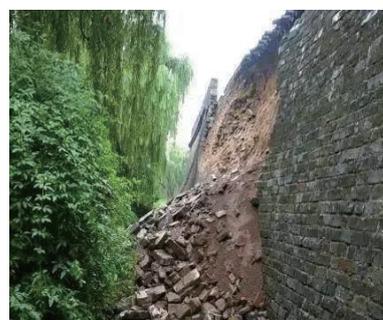
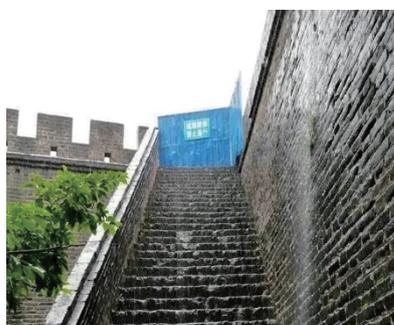
Fig. 20 after the damage<sup>19)</sup>

Fig. 21 after the damage<sup>19)</sup>

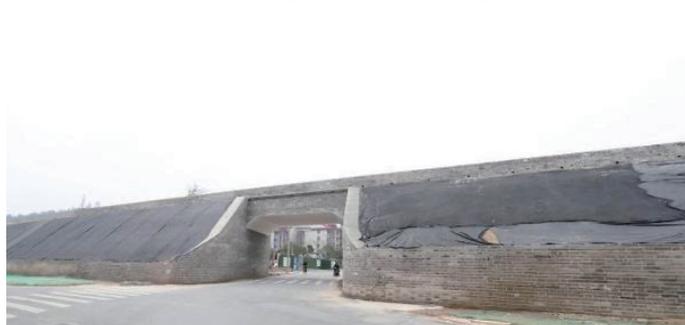
Fig. 22 in the renovation<sup>21)</sup>
