Research on the Damage of Cultural Relics Buildings and Disaster Prevention Countermeasures in Heavy Rain in Henan, China

In July 2021, China's Henan Province suffered from extreme rainstorms, and cultural relics were damaged to varying degrees in the torrential rain disaster. A total of 563 cultural relics were affected. Among all the disaster-affected cultural relics, the cultural relics buildings were damaged in the largest number, with a total of 470. The report examines the damage mechanism and causes of the rainstorm disaster and cultural relics buildings through literature collection and field research, and examines the damage of typical cultural relics buildings. Suggestions on disaster prevention and mitigation methods for buildings.

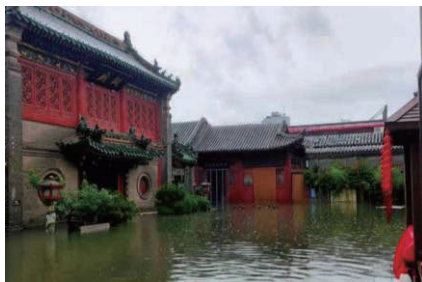
Under the influence of continuous heavy rainfall, the guild hall was washed by rainstorm and soaked in accumulated water (Fig. 2). Although the overall preservation of the building is good, the structure is stable, but there are roof leakage, doors and windows columns paint off (Fig. 3). The building of the hall is a brick-

Fig. 2 Water in the Hall

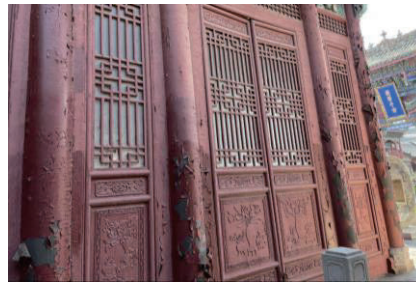
wood structure, and the rainstorm mainly causes serious roof damage of the east and west compartments, and many roof leakages. Leakage occurs in the gullies of the hall, the north house of the west span courtyard and the north house of the east span courtyard.

Fig. 3 Paint peeling off

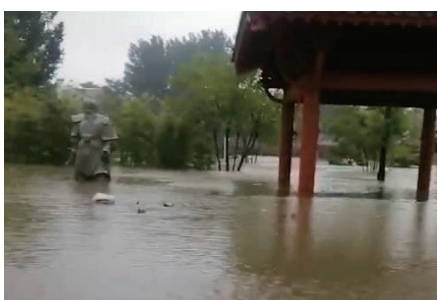
Jigong Temple is located in Zhengzhou City, Henan Province, China. The temple was built in the Tang Dynasty, and now the temple is rebuilt after the Tang Dynasty. Under the influence of this rainstorm disaster, Jigong Temple was soaked in accumulated water⁴⁾. And the roof wall was scoured by rainstorm (Fig. 4). Continuous heavy rainfall results in unsmooth drainage and serious surface water accumulation, resulting in erosion of foundation and peeling off of wall paint (Fig. 5). The surrounding environment of Jigong Temple was damaged by large area of rainwater immersion, sludge sand accumulation, vegetation greening and other cultural relics.

Fig.4 Jigong Temple accumulated water⁵⁾

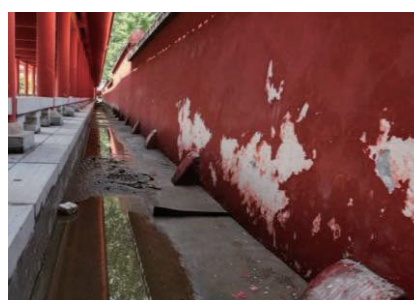
Affected by the uplift of the surrounding ground and the lack of drainage capacity of the cultural relics buildings, the cultural relics buildings such as the Jigong Temple in this heavy rain disaster were soaked in the accumulated water for a long time. Under the scouring of the rainstorm, the roof leaked, and the rainwater penetrated into the room through the cracks in the components. The indoor beams and columns were eroded by the rainwater, and the surface paint fell off.

Fig.5 paint peeling off⁵⁾
