# Man's contribution to our cultural heritage degradation: A case study of Moinuddin Chishti Dargah

Ar. Sakriti Vishwakarma<sup>1</sup>

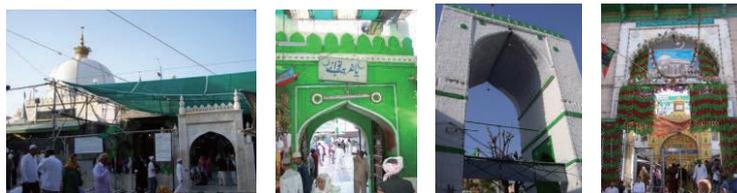
Figure 8: Structures of the complex such as Main Courtyard, Sandali Gate, Buland Darwaza, Nizami Gate (Source: Author)

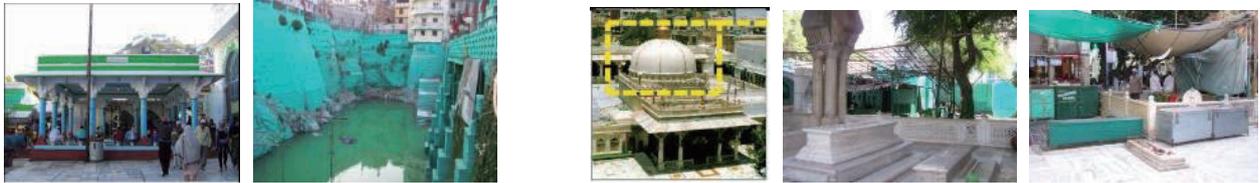
Presented by the Queen Mary when she visited Dargah in the early 1900's, this mosque is inspired from the Sultanate architecture which has a roof supported by brackets and columns which used to be constructed during the Sultanate time. It is covered by a flat roof and is made up of red sandstone but now has gone

through many changes and acrylic paint has taken over the existing finish.

Earlier a water reservoir has gone through many changes over time. Here Moinuddin Chishti used to perform the ablutions. Later many changes were done like deepening the tank and adding steps, and then it was finally converted into a baoli or a step well.

Figure 10: Historic Wazu's in the complex-Queen Mary's Wazu (Left) & Jhalra Figure 11: Funerary Structures- Moinuddin Chishti's tomb (Left), various graves on the site(Middle), Historic graveyard and the encroachments (Right). (Source: Author)

Square in plan with a dome supported on the roof, this structure had gone through many changes. Made of sandstone with lime plaster finish and a gold finial at the top, the faceted dome structure has various Islamic quotes written all over the structure.

The entire complex is occupied by various graves of rulers/devotees/noblemen/merchants, and so on, some are covered by permanent structures while some have temporary, and some are open also.

The Historic graveyard is also there which now is being encroached upon; it is the only area with a green open space and here reside graves of various kings, rulers, and noblemen.

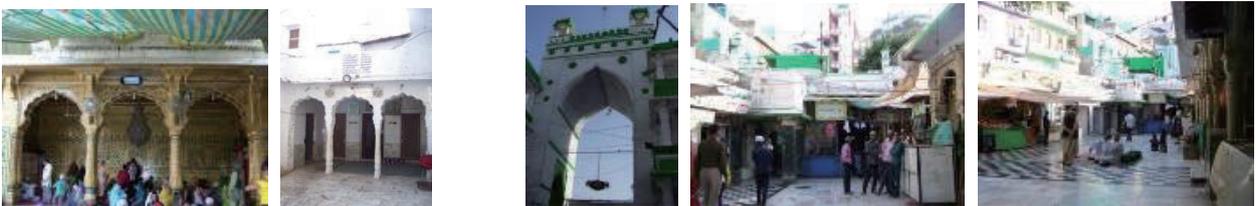
Various hujras were constructed by the rulers for the khadims as their residence or meditation places. The entire complex is filled with these small rooms as residences housing in people throughout the complex.

Numerous dalans were constructed by rulers/devotees as resting places for the pilgrims and for an artist to perform. These structures were inspired by different architectural characteristics of different periods.

Figure 12: Hujras and dalans used as residences in the complex (Left) Figure 13: Buland Darwaza one of the gateways, Courtyards occupied by shops (Source: Author)

The complex has around 13 gateways, the earliest being the Buland Darwaza constructed in the Sultanate time. These gateways have various architectural features and elements and rituals associated with them.

Various commercial activities are performed in this complex such, many shops selling souvenirs, flowers, chadars for the rituals are kept. These shops have majorly come up in the Dalans and the courtyards with temporary awnings.

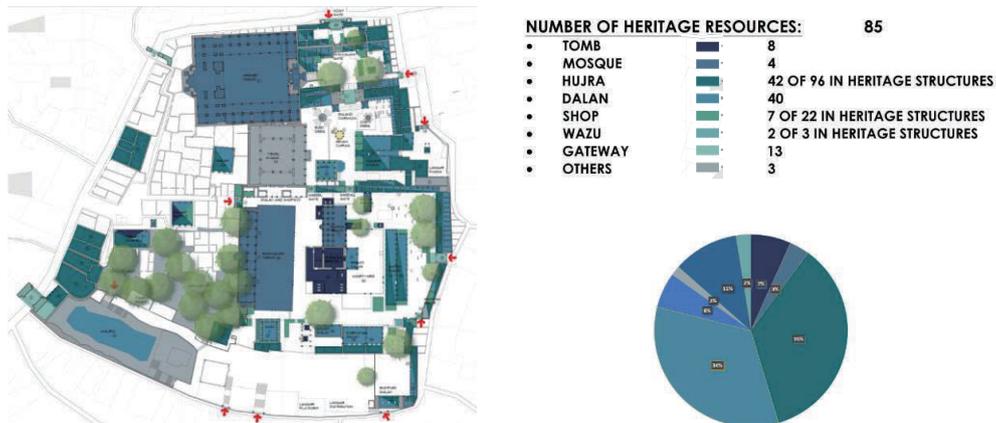
Figure 14: Typology analysis for the heritage complex (Source: Author)

The heritage structures in the Dargah complex can be subdivided into numerous typologies namely tomb, mosque, hujra (earlier residences now mostly used as office spaces), dalans etc. which have modified the character of the place into a mixed-use. A total of 85 heritage structures could be identified which have the overlap of uses with another such as commercial, residential and religious practices are all observed simultaneously in the same structure. The site has the maximum number of hujras and dalans.

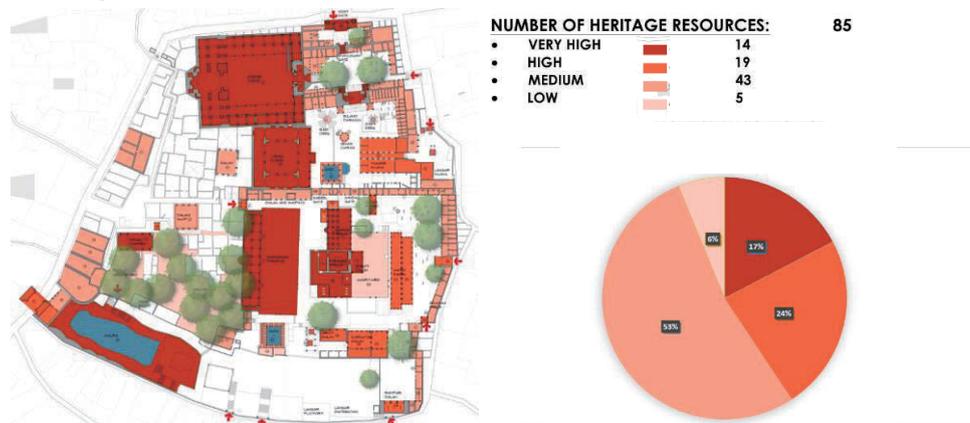
Figure 15: Architectural significance analysis for the heritage complex (Source: Author)

The architectural significance implies the character of a structure based on their architecture which is evaluated according to their importance under four categories that is Historical importance, Associational value, Architectural features, characteristics and present condition of the structures. The structures under the

“Very High” category are structures built by prominent rulers with exceptional architectural characteristics or have been in existence from its inception, the structures with “High” category are the ones which are built by lesser known rulers or noblemen but have high architectural significance. The third category structures are the ones who have “Medium” significance, and these are significantly altered to a great extent, and the fourth category of “Low” contains structures which have low architectural significance or have been altered beyond recognition.

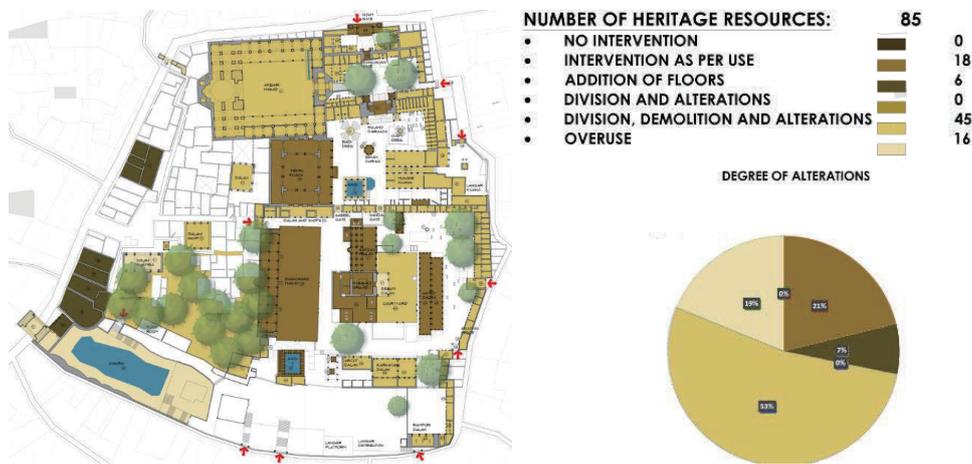
Figure 16: Analysis of the degree of intervention of the heritage structures in the complex. (Source: Author)

The degree of Interventions is the study done to identify the historically important structures for immediate preservation initiatives to prevent further degradation. The level of interventions recorded was alarming as the site does not have any heritage structure left which has not been either modified or altered. The main shrine area, mosques, and main dalans have been modified according to the use, such as the addition of rooms or spaces, blocking of some walls. The hujras and main dalans have suffered the most because of the ownership as they have been either subdivided or demolished and new structures have been built in their place, or there has been the addition of columns and materials which are not compatible with the existing fabric.

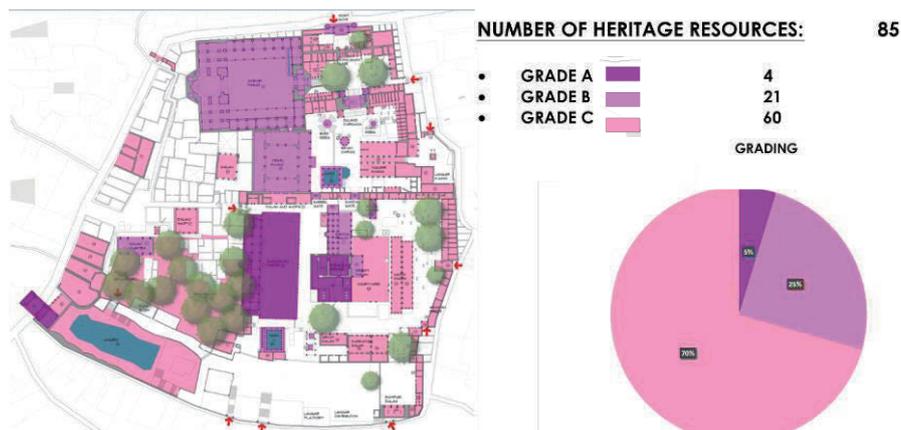
Figure 17: Structural Condition assessment highlighting the structures which need immediate attention. (Source: Author)

Condition assessment is a consolidated study of present structural, cultural and architectural condition of all the structures to understand the quality based upon their architectural significance, compatible use, the degree of intervention, structural quality, etc. With Grade A depicting the structures which are stable and have a minimum intervention, Grade B having structures of medium level interventions and Grade C where the structures despite of high architectural significance have poor quality and need immediate attention.

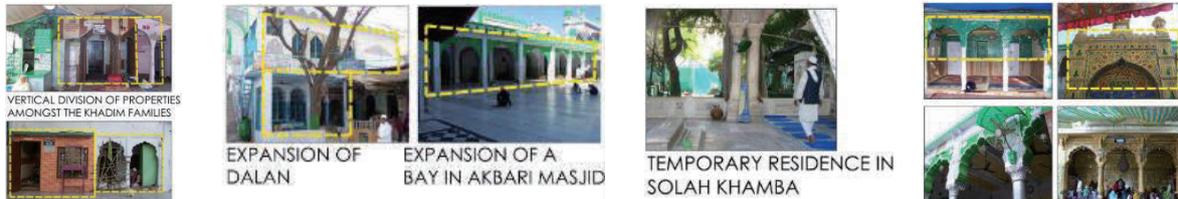
Loss of heritage structures as the addition of various elements such as RCC columns and arches is observed. Change in the material is also observed as more tile work are being introduced as each property tries to look different.

Figure 18: Transformations through the division of properties, expansion of properties, encroachments and external ornamentation with incompatible materials (extreme right). (Source: Author)

Expansion of properties is occurring in the complex due to various reasons. Some properties are expanding vertically, and some are expanding horizontally, for example, in the Akbari Masjid the addition of a new bay has been done as the previous bay had been converted into stores and rooms. This leads to increase in stress and causing deterioration of the structures.

Due to a lack of vigilance various structures are being encroached upon. Heritage is being lost due to an increase in stress and lack of maintenance due to the encroachments.

Incompatible materials such as acrylic paints are being used on the structures for external ornamentation which is leading to deterioration of the existing structures and decreasing the authenticity. These materials are incompatible and due to layers and layers of application of these paints, the loss of original material is observed.

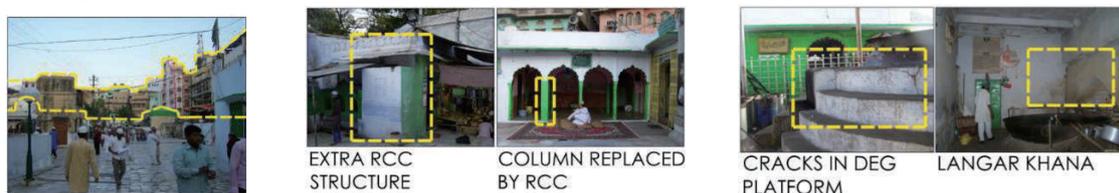
Due to the uncontrolled construction of multi-storied around the complex, loss of skyline is observed along with a loss of sense of space.

For extra structural reinforcement, the addition of various RCC columns is observed instead of the proper strengthening of the columns. The traditional stone columns are either being replaced or modified without prior checking of the impact which also affects the visuals and the character of the space.

Figure 19: Transformations through uncontrolled construction, structural reinforcement, and overuse(extreme right). (Source:Author)

Due to overuse of some structures, cracks and deterioration are observed. There is also a lack of maintenance of the same historic structures which are causing them to degrade.

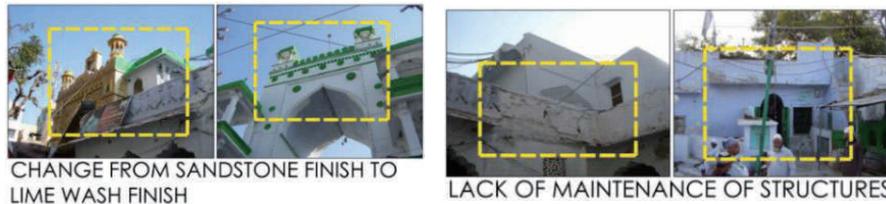
Figure 20: Transformations through the change of materials and lack of maintenance (extreme right). (Source: Author)

Change in original materials by application of various unauthentic materials are observed which are changing the architectural fabric of the place.

Lack of maintenance of almost all the structures in the complex are observed, there is no periodic maintenance plan which is causing a major portion of the structure to deteriorate.

(1) Active engagement with the local communities. We must involve all stakeholders in the maintenance and management of the site. (2) In some cases, engaging religious authorities will also help escalate the process of conservation, since this particular site, the Dargah, is a holy pilgrimage as well. (3) We must increase the awareness of this issue, a significant portion of today's youth are unaware that historic national treasure like the Dargah is under severe existential threats. (4) We need an integrated conservation management plan for all historic sites, especially the Dargah. This plan needs emphasis on conservation, and the decision-making procedure regarding historic sites must involve various experts. (5) Certain practices, like qawwalis, the Khadim community practices, are intangible, but they are heritage themselves, and we must strive to conserve them as well. (6) Immediate conservation action plan needs to be formulated for the preservation of Grade A structures categorized above. (7) We must bring forward sensitive proposals which apply the minimum intervention to the modern fabric and bring out the maximum benefit.
