Study on the Disaster Prevention Countermeasures about Historic Blocks in China

—Taking A Yi Dun District of Yi Ning in Xingjiang province as the example

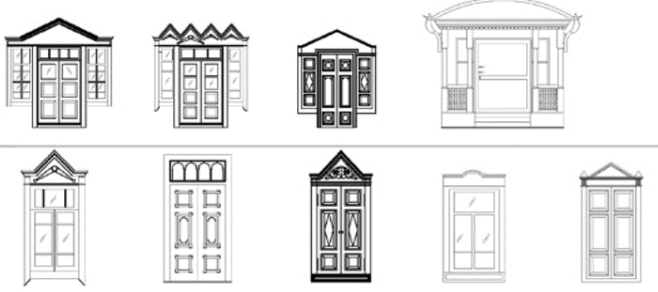
Fig.4 Architectural features analysis

The architectural style of A Yi Dun Street is changeable, and the types of form are rich. The building structure is mainly brick and wood structure. The design foundations for the bases, doors, windows, verandahs, roofs, cornices, and gates have been combined for many years to create experience and decorative arts, forming a suitable local architecture with strong ethnic characteristics. (Fig.4)

| Base | Due to the fact that there is much rain in the area in autumn and the amount of snowfall in winter is large, the form of residential areas gradually evolves into a high platform. | |
| Doors and windows | The doors and windows of the houses are all wooden, with ventilation and lighting, and the function of indoor and outdoor communication. At the same time, it is also one of the focal points of residential building decoration. | |
| Veranda | There are two types of flat roofs and sloping roofs in modern representative residential houses. One of the four slope roofs is influenced by the Russian architectural style. | |

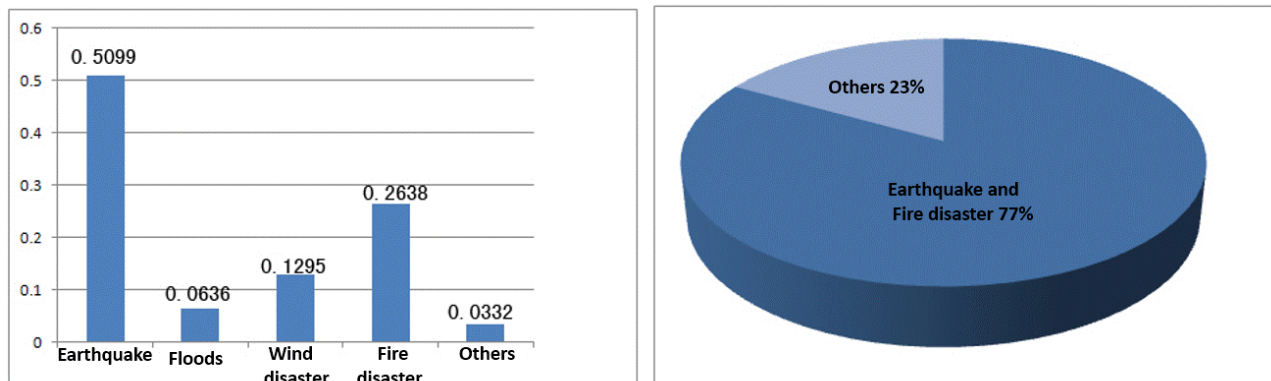
Fig.5 The proportion of safety risk factors
(source: self-portrait)

The types of disasters that affect safety include: earthquakes, floods, wind disasters, fires, and other disasters. For A Yi Dun History Street, a comparison of the types of disasters found that earthquake is the most influential factor. (Fig.5)

Through the analysis of the weights of the disaster factors in the A Yi Dun historical block area, we can see that the primary hazards affecting the safety of A Yi Dun historic blocks are mainly earthquakes and fires. Therefore, the design of the disaster prevention and mitigation of the A Yi Dun historical block mainly includes three Aspects: (1) The earthquake strategy; (2) The fire disaster strategy.

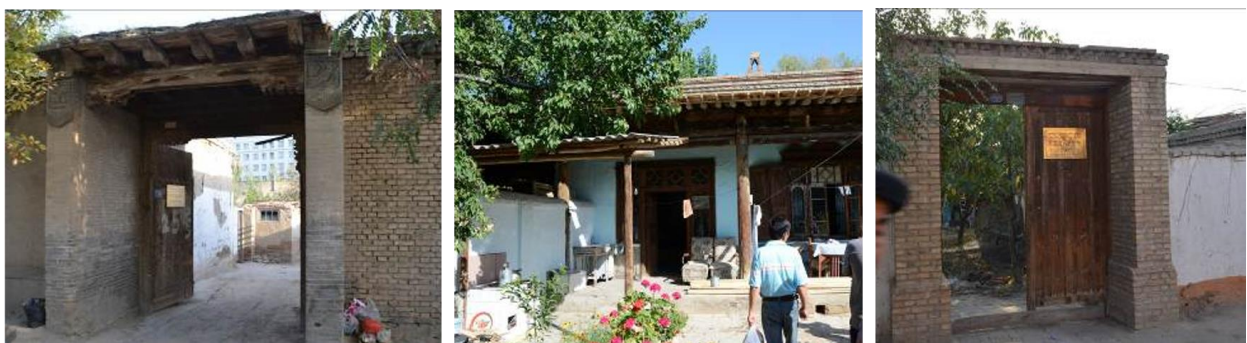
Fig.6 The building is urgent to rescue and repair

The public facilities in A Yi Dun Historical District are aging and backward, and some of the buildings are of poor quality and do not have wind resistance. (Fig.6)

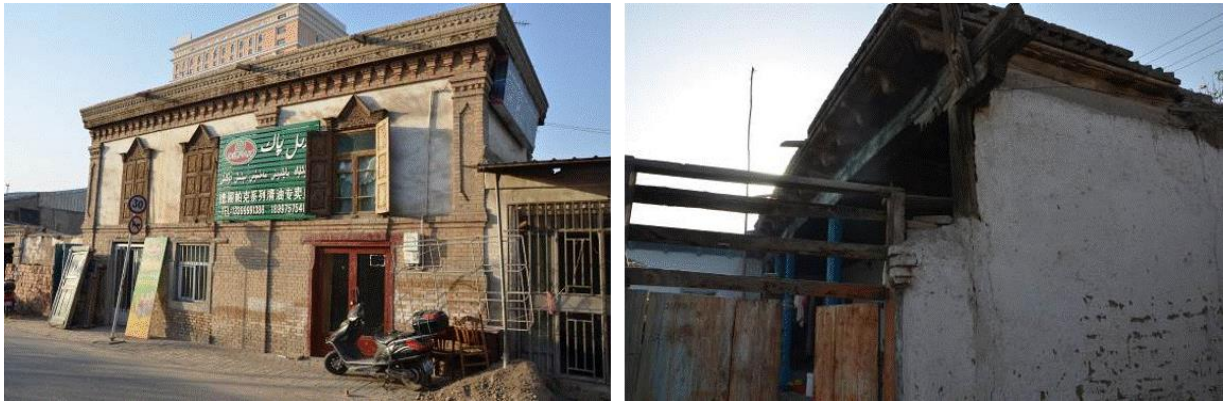
Fig.7 Current houses
(source: the paper of Lina Zhang)

There are three major problems in the existing buildings in the block: poor fire separation, poor safety evacuation, complex functions, and many hidden fire hazards; construction fire resistance is low, fire load is large, fire facilities are few, and methods are simple. (Fig.7)

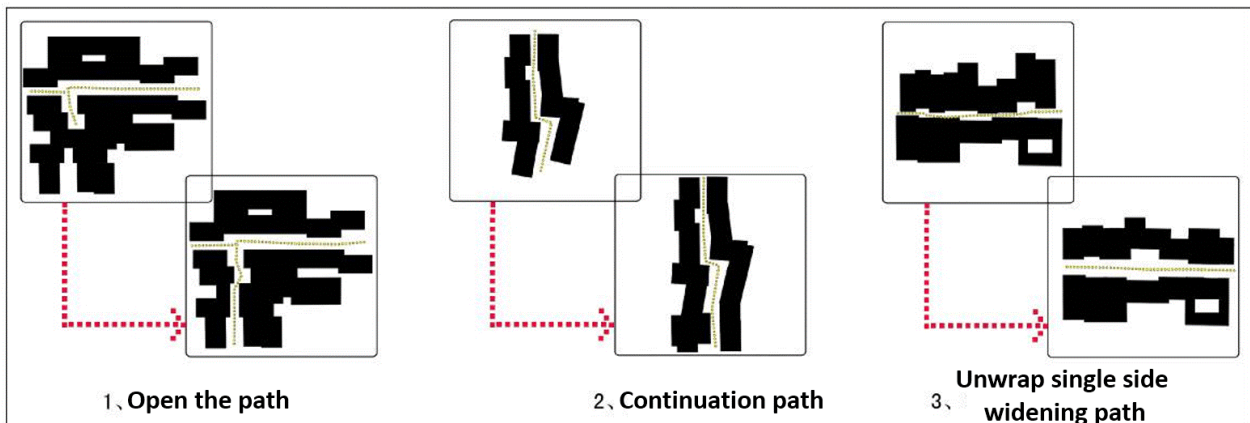
Fig.8 Block the road reconstruction
(source: self-portrait)

Mainly from the improvement of the building's seismic capacity, rational planning of shelter sites, effective combing of safety evacuation routes, appropriate reduction in building density and update the layout of the form. (Fig.8)
